Manhole Inspection Summary

Manhole # S27U__005MH

Insp Date: **4/23/08 9:04 AM**

Location Address: **1700 Ridgely ST**

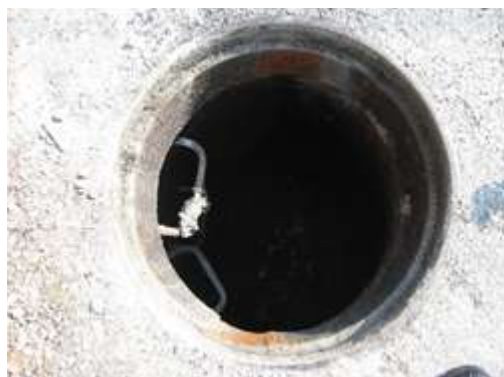
Defect 3

Offset: **1.5** (in.)

Condition: ☐ Sound ☐ Cracked ☒ **Leaks**

☒ **Evidence Of Surcharge** Depth: **6** (ft.) ☐ Active Surcharge Present

Frame leaks & Offset; Surcharge Evidence

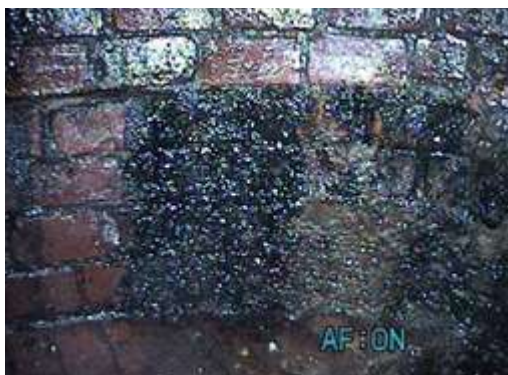
Defect 2

Condition: ☐ Sound ☐ Cracked ☐ Root Intrusion ☐ Loose Brick ☒ **Deteriorated**

Infiltration: ☐ None ☒ **Joint** ☐ Cracks ☐ Mortar ☐ Roots ☒ **Wall**

Deteriorated Corbel, Active Infiltration Corbel

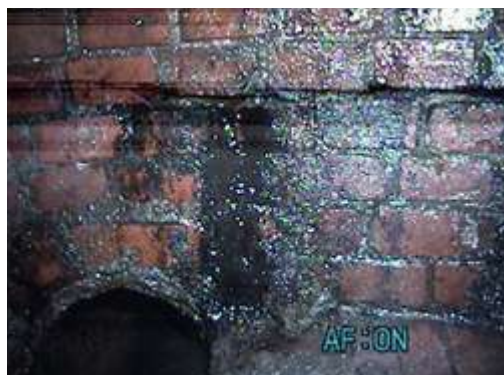
Defect 1

Condition: ☐ Sound ☐ Cracked ☐ Root Intrusion ☐ Loose Brick ☒ **Deteriorated**

Infiltration: ☐ None ☐ Joint ☐ Cracks ☒ **Mortar** ☐ Roots ☒ **Wall**

Condition: ☐ Sound ☐ Cracked ☐ Root Intrusion ☒ **Deteriorated** ☐ Leaks ☐ Debris

Deteriorated Barrel, Active Infiltration Barrel, Deteriorated Bench

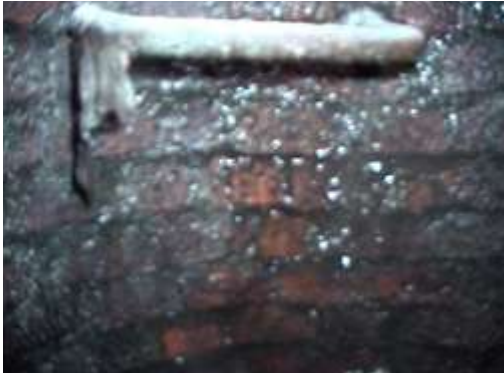
Defect 5

Count: **8** Missing: **0** ☒ **Corroded**

corroded steps, signs of surcharge 8 feet

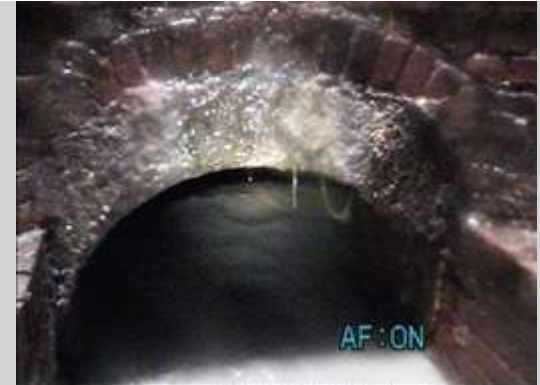
12 O'Clock Outflow

33 in. Circular Gravity Sewer
Pipe Out @ 12 O'Clock

Pipe Height: **36** (in.) Rod and Bar (Angled)
Pipe Material: **Clay** ☐ Pipe Lined
Invert Depth: **15.37** (ft.) Flow Characteristics: **Fast**
Deposits: ☒ None ☐ Mud ☐ Sludge ☐ Debris ☐ Grease
Silt Depth: **0** (in.) Deposits Extent:
Infiltration: **Evidence** Pipe Seal Cond: **Unknown**

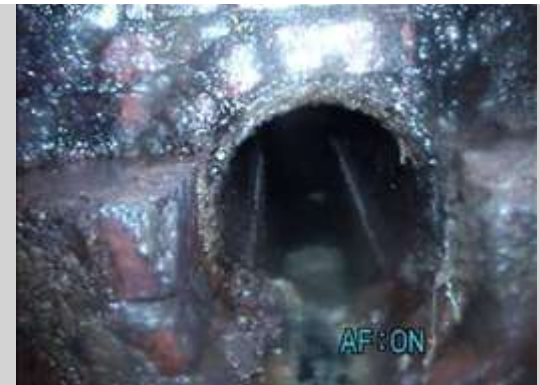
3 O'Clock Inflow

10 in. Circular Gravity Sewer
Pipe In @ 3 O'Clock

Pipe Height: **10.8** (in.) Rod and Bar (Angled)
Pipe Material: **Clay** ☐ Pipe Lined
Invert Depth: **13.59** (ft.) Flow Characteristics: **Slow**
Deposits: ☒ None ☐ Mud ☐ Sludge ☐ Debris ☐ Grease
Silt Depth: **0** (in.) Deposits Extent:
Infiltration: **Evidence** Pipe Seal Cond: **Unknown**

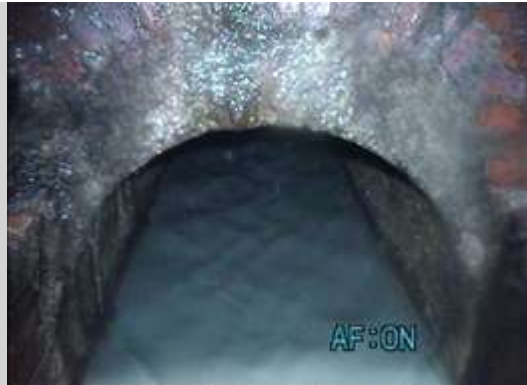
6 O'Clock Inflow

39 in. Circular Gravity Sewer

Infiltration: **Evidence** Pipe Seal Cond: **Unknown**

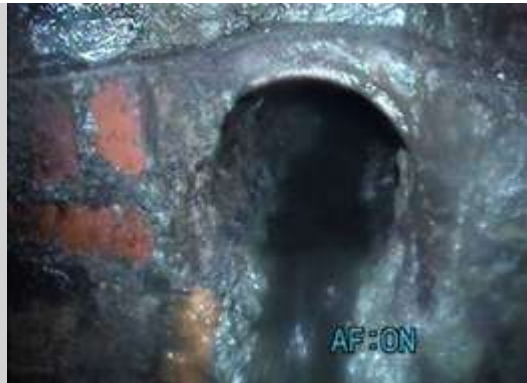
9 O'Clock Inflow

10 in. Circular Gravity Sewer

Infiltration: **Evidence** Pipe Seal Cond: **Unknown**
